Manhole Inspection Summary

Manhole # S09MM_002MH

Insp Date: **1/21/09 11:45 AM**

Location Address: **3300 GWYNNS FALLS PKWY**

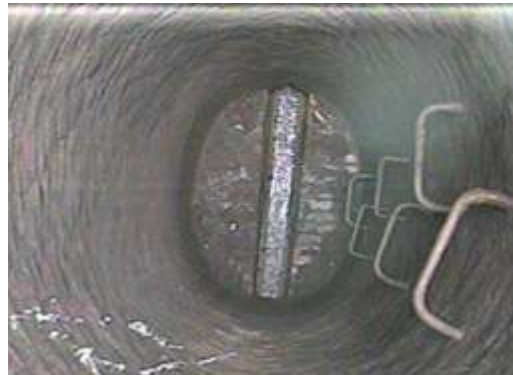
Top View

Count: **9** Missing: **1** ☒ **Corroded**

CORRODED AND MISSING STEPS

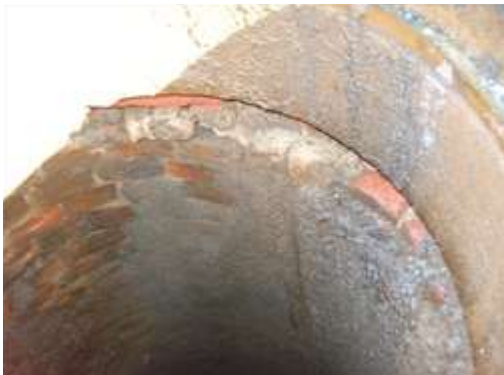
Defect 2

Condition: ☐ Sound ☐ Cracked ☐ Root Intrusion ☒ **Loose Brick** ☒ **Deteriorated**

LOOSE BRICKS AND DETERIORATED CHIMNEY

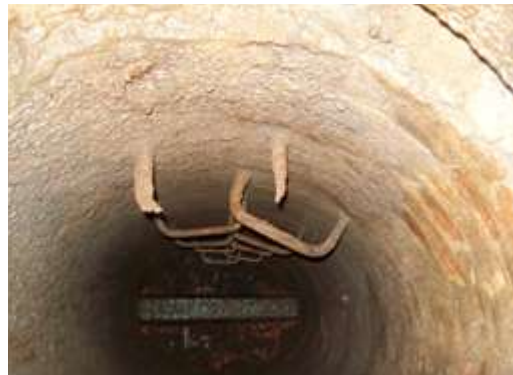
Defect 1

CORRODED AND MISSING STEPS
